ChemScan® UV-6100 Process Analyzer

PROJECT REPORT AND DATA SUMMARY
MULTIPLE PARAMETER WASTEWATER MONITORING
PERFORMANCE EVALUATION

City of Calgary
Bonnybrook Wastewater Treatment Plant
Calgary, Alberta, Canada

Published By:
Applied Spectrometry Associates, Inc.
W226 N555G Eastmound Drive
Waukesha, WI 53186

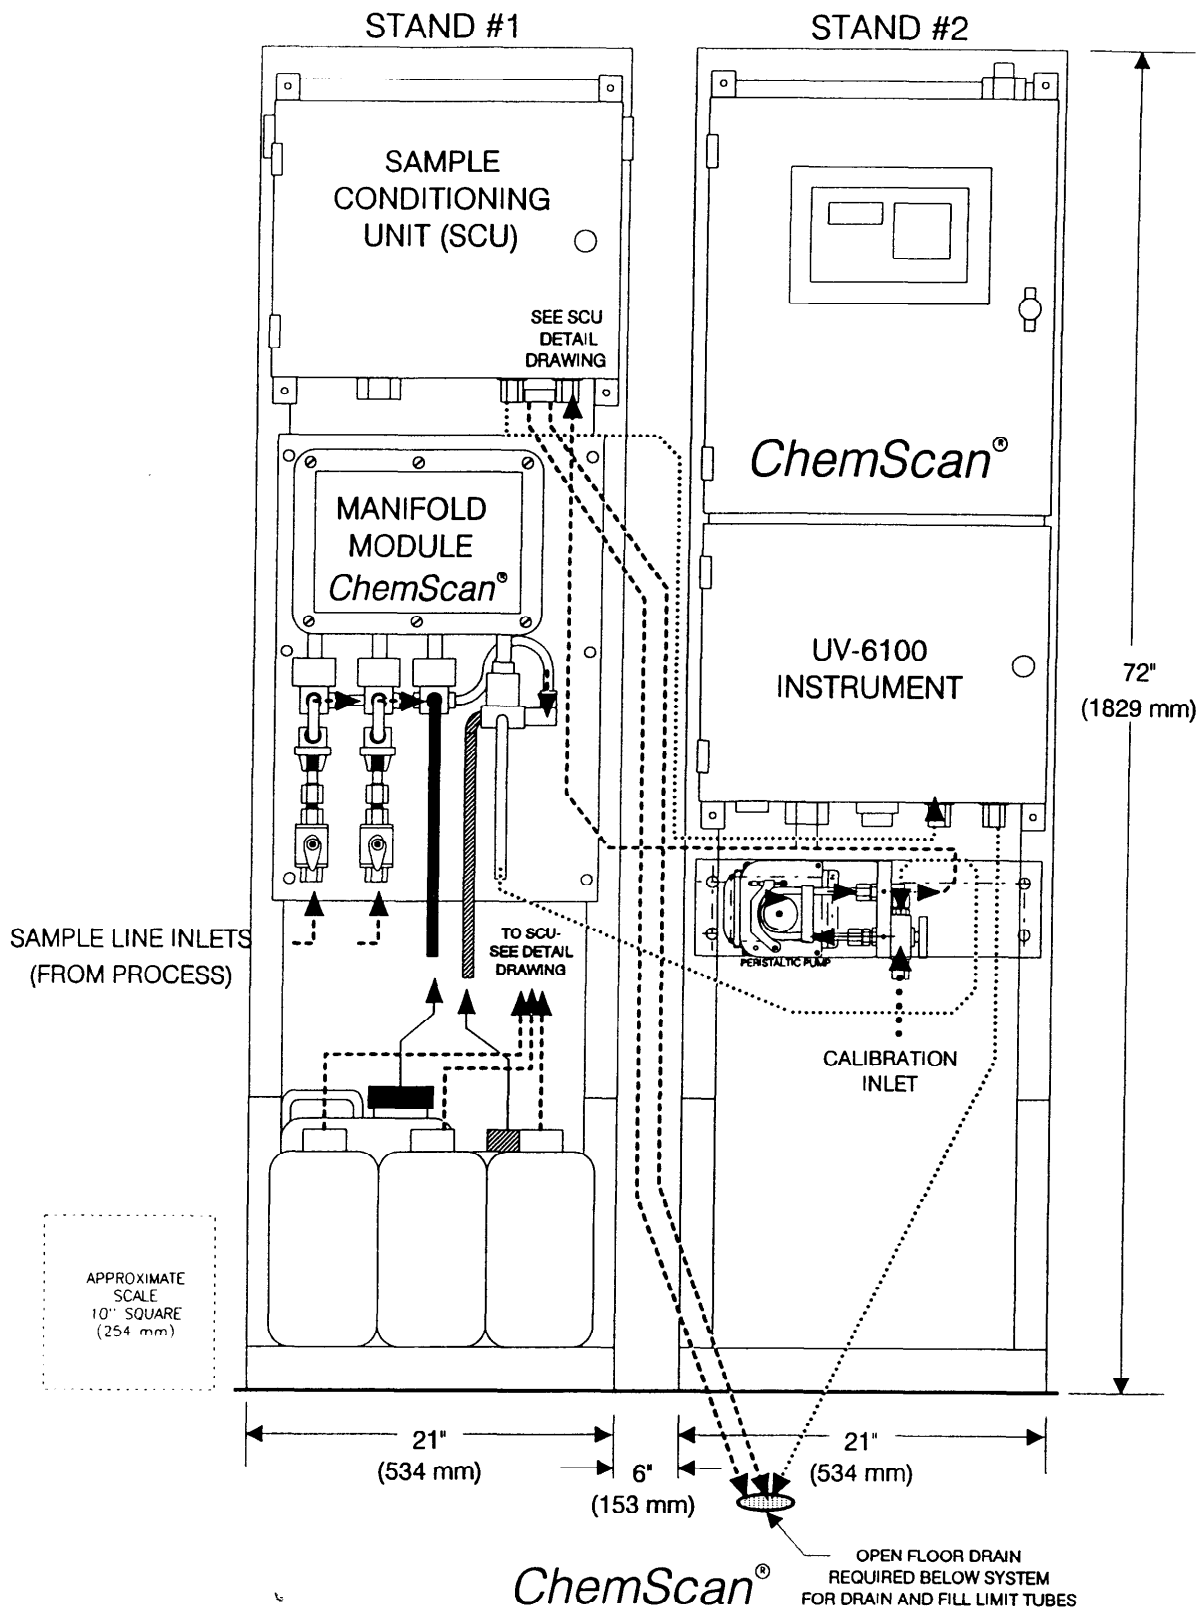
ChemScan®
 System Installation Diagram - Plumbing Overall View
 -Typical Mounting Configuration -

Attachment 2 shows the general arrangement of the ChemScan System including the UV-6100 Instrument, Analyzer Pump, Sample Conditioning Unit, Manifold Module and Mounting Stands.

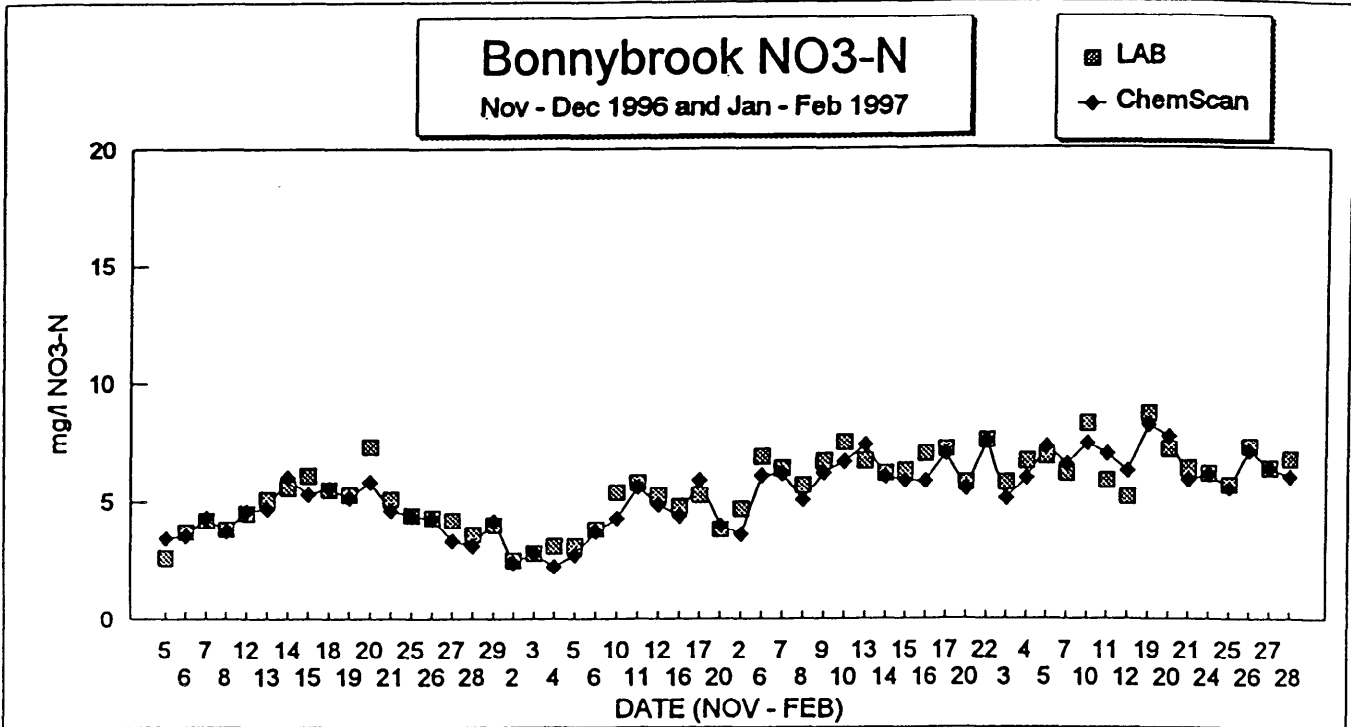
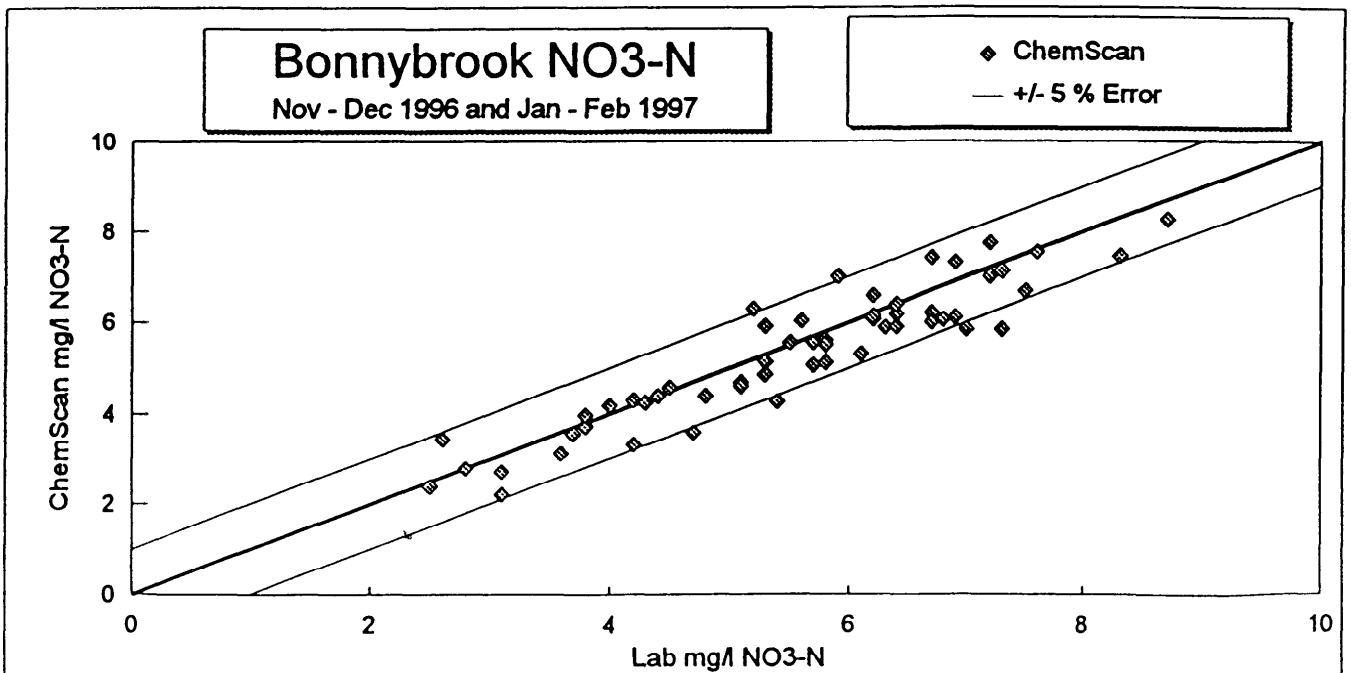
Attachment 3

ChemScan Analyzer NO3-N Data Bonnybrook AWWTP

Nov. Average Absolute Error	2.0%
Dec. Average Absolute Error	1.3%
Jan. Average Absolute Error	1.8%
Feb. Average Absolute Error	1.6%
Total Average Absolute Error	1.7%

Attachments 3, 4 and 5 show the evaluation results for a four month period comparing on-site laboratory analysis of grab samples with the ChemScan analyzer results for nitrate, ammonia and phosphate. ASA specifications show a $\pm 5\%$ accuracy for each of these parameters. Data for each parameter show the absolute error to be better than specified during each month of the evaluation and for the entire four month evaluation period as a whole.

This performance was achieved without recalibration of any of the parameters during the test period (although the operator did perform one slope and intercept adjustment during the period on the ammonia calibration).

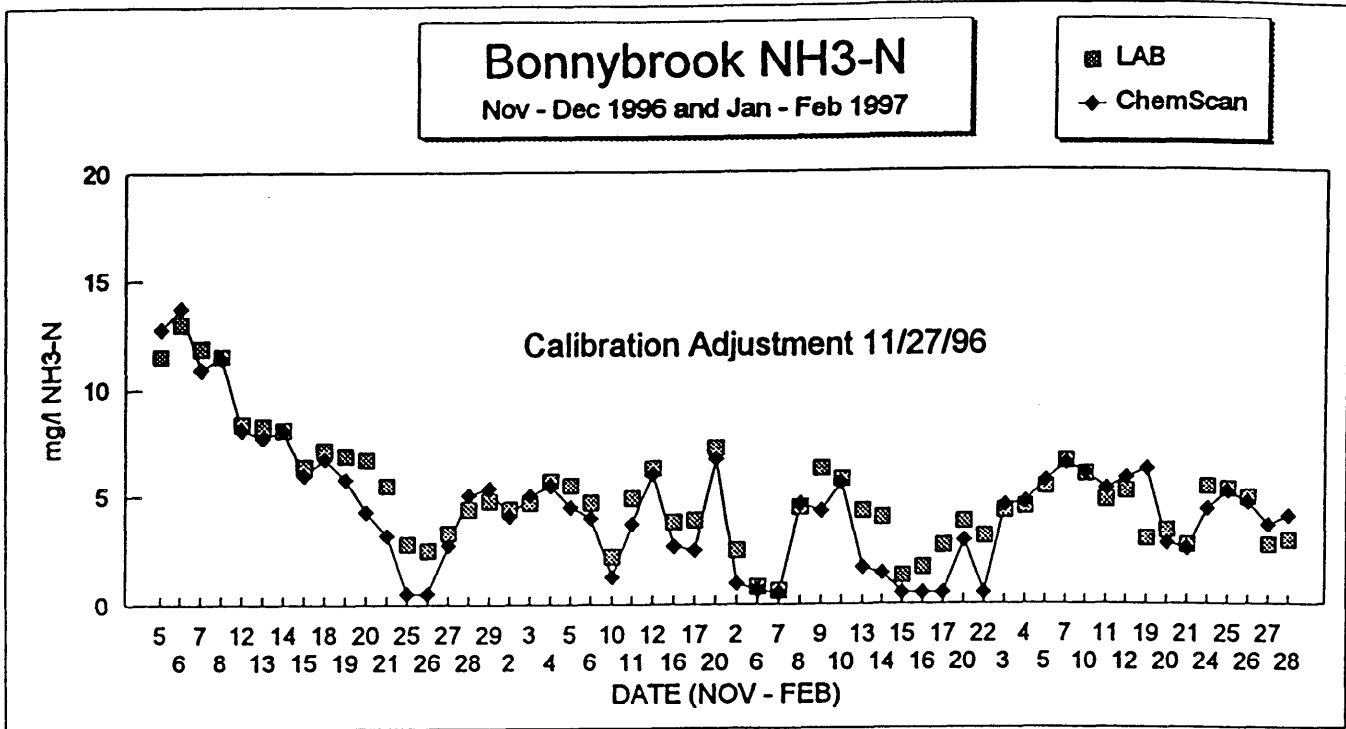
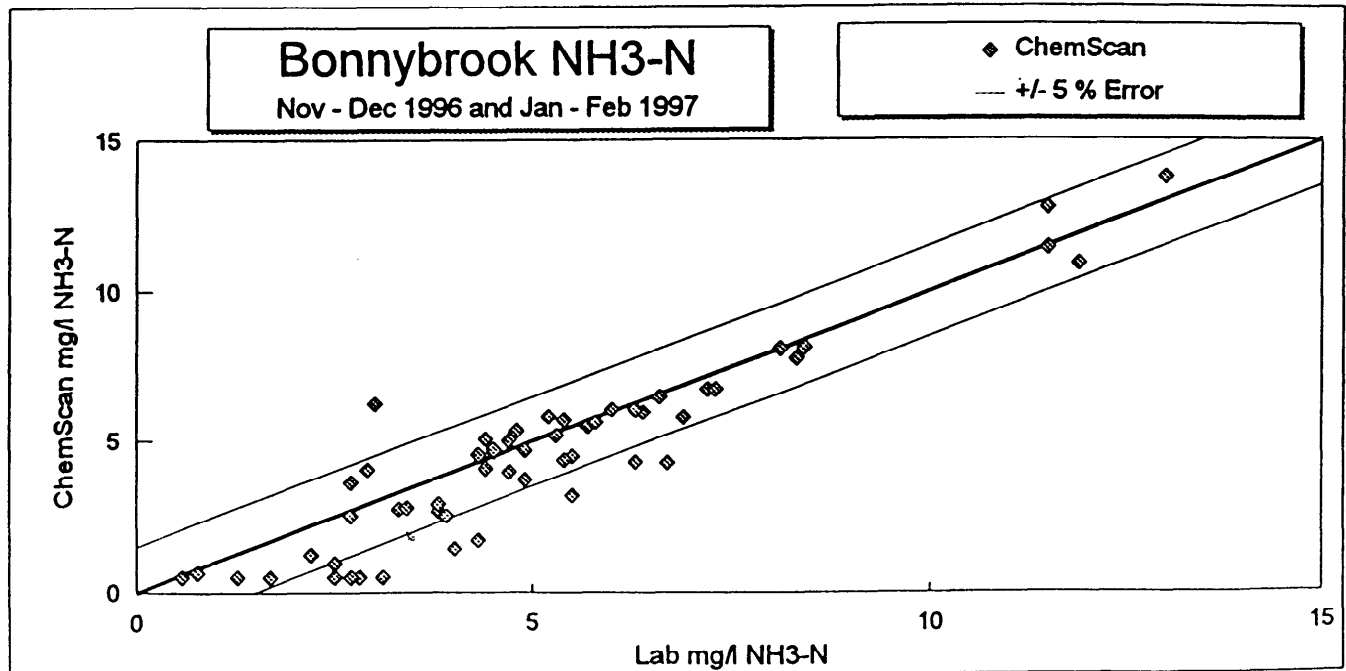
Attachment 4

ChemScan Analyzer NH3-N Data Bonnybrook AWWTP

Nov. Average Absolute Error	3.3%
Dec. Average Absolute Error	2.5%
Jan. Average Absolute Error	4.4%
Feb. Average Absolute Error	2.5%
Total Average Absolute Error	3.0%

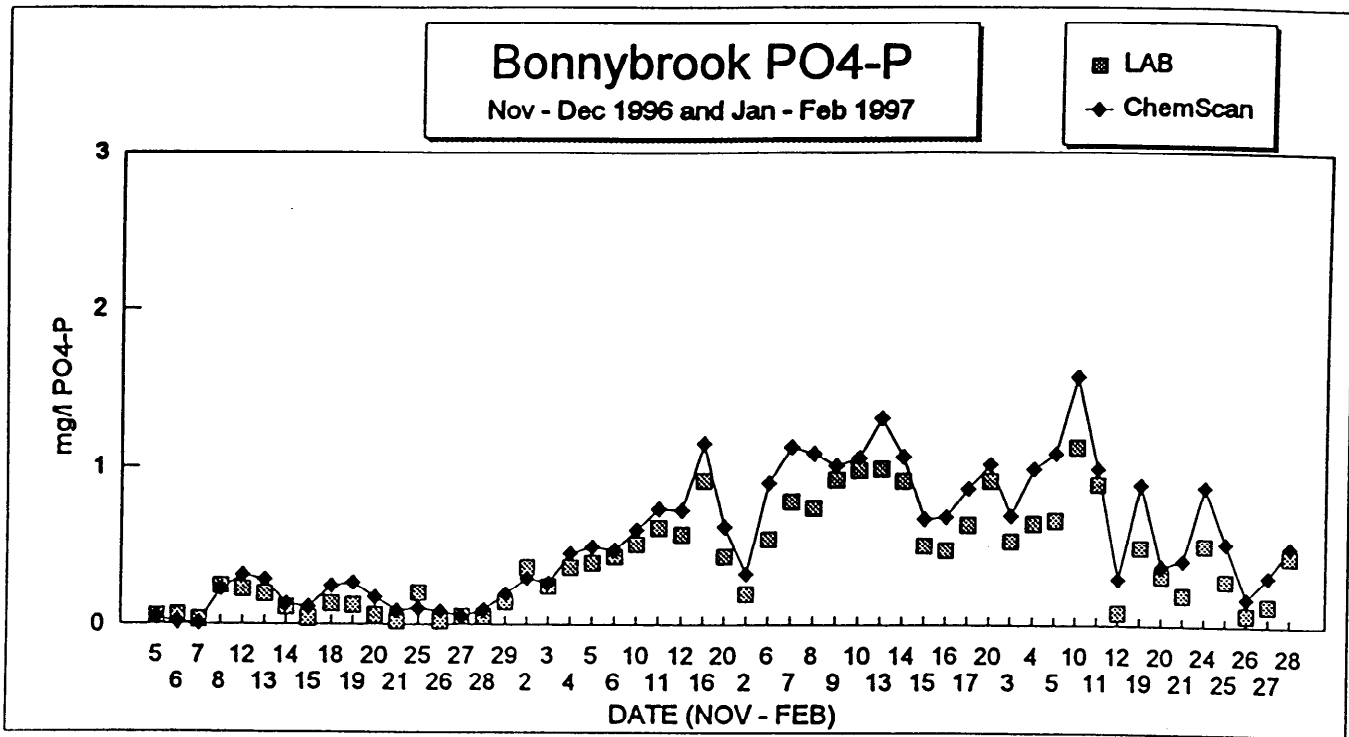
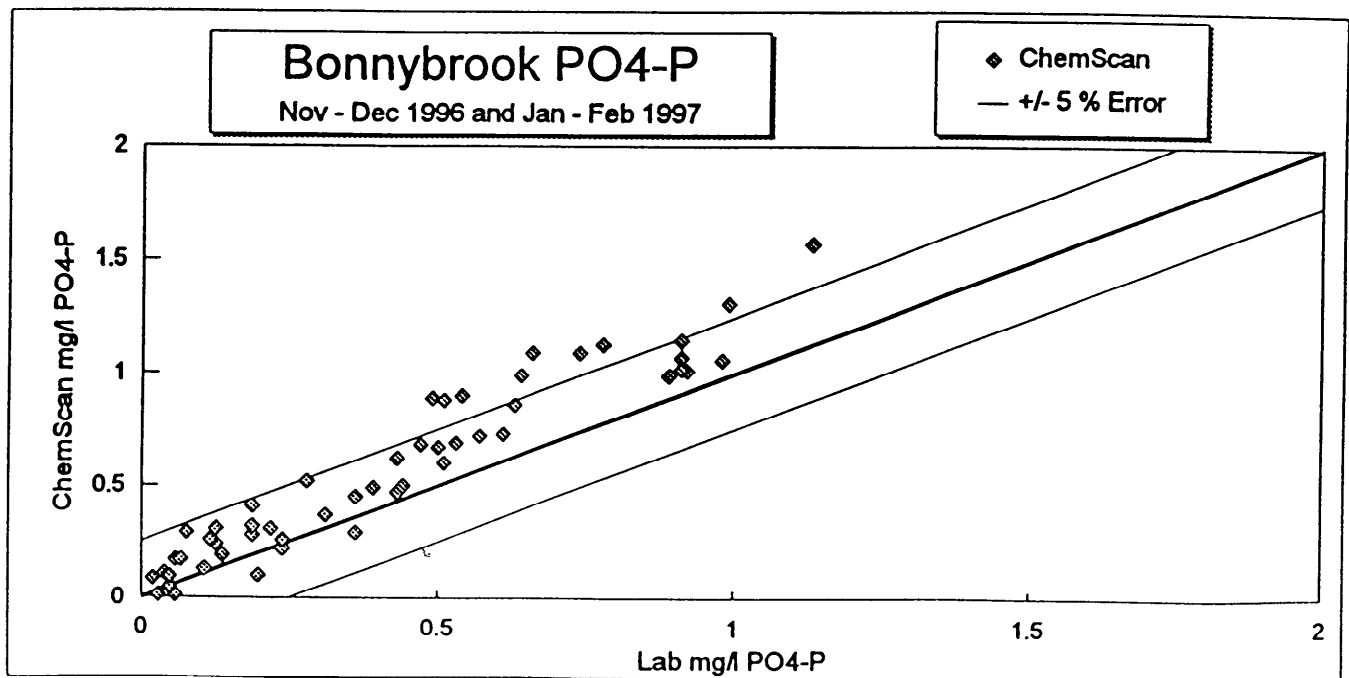
Attachment 5

ChemScan Analyzer PO4-P Data Bonnybrook AWWTP

Nov. Average Absolute Error	1.2%
Dec. Average Absolute Error	2.0%
Jan. Average Absolute Error	4.7%
Feb. Average Absolute Error	4.3%
Total Average Absolute Error	3.0%
